Aircraft Accident Report

SILKAIR FLIGHT MI 185

BOEING B737-300

**Investigation of Aircraft Accident
SilkAir Flight MI 185
Boeing B737-300, 9V-TRF
Musi River, Palembang, Indonesia
19 December 1997**

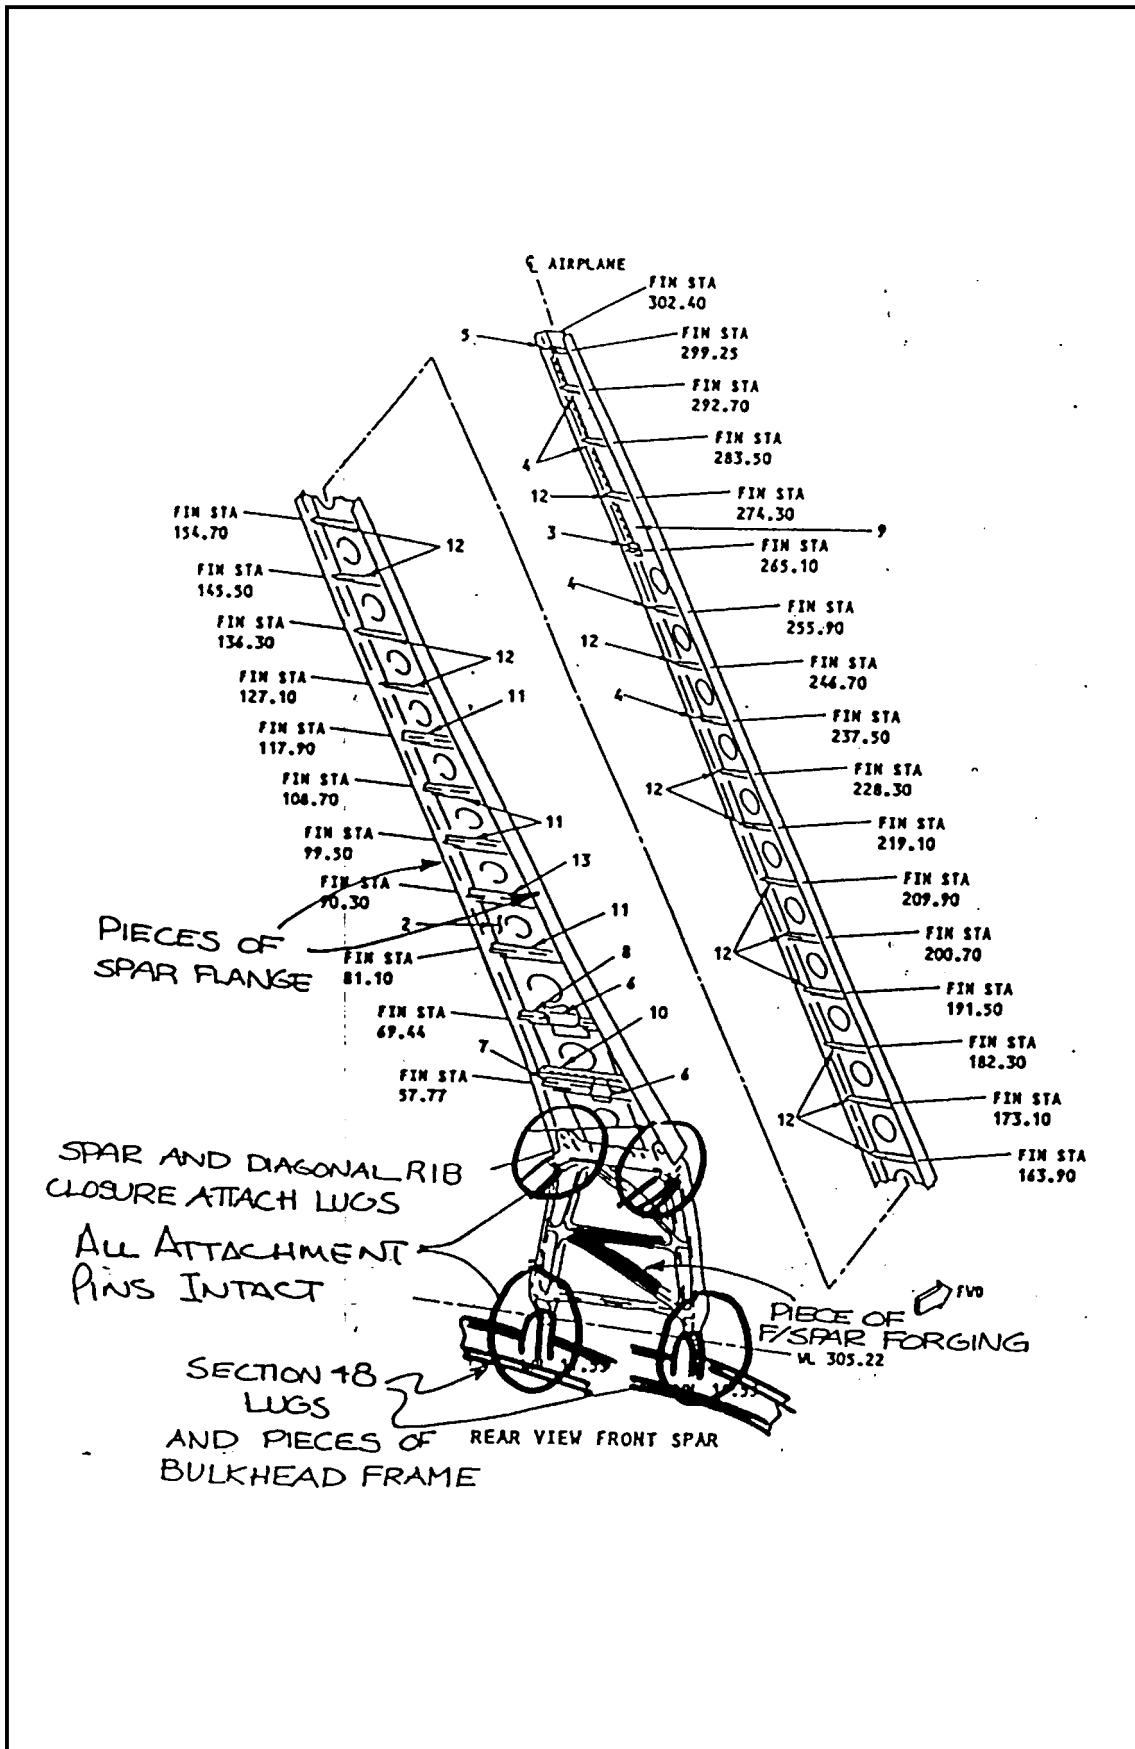
Figure 10.g Front Spar Vertical Stabilizer

Vertical stabilizer (Figure 10.g) - All the vertical stabilizer spar terminal fittings and the fin trailing edge hinge fittings were accounted for at the crash site, indicating that the vertical stabilizer structure was intact at impact. Damage to the vertical stabilizer precluded a full accounting of the front spar and interspar structure. The rudder upper hinge showed evidence of over-travels in the left and right directions. Other hinges exhibited twisting damage consistent with excessive rudder movement in the clockwise direction (looking forward). However, it could not be determined when the twisting damage was incurred.
